REPORT OF INVESTIGATIONS/1989

Effects of Structural Faults on Ground Control in Selected Coal Mines in Southwestern Virginia

By Gregory M. Molinda and David K. Ingram

BUREAU OF MINES

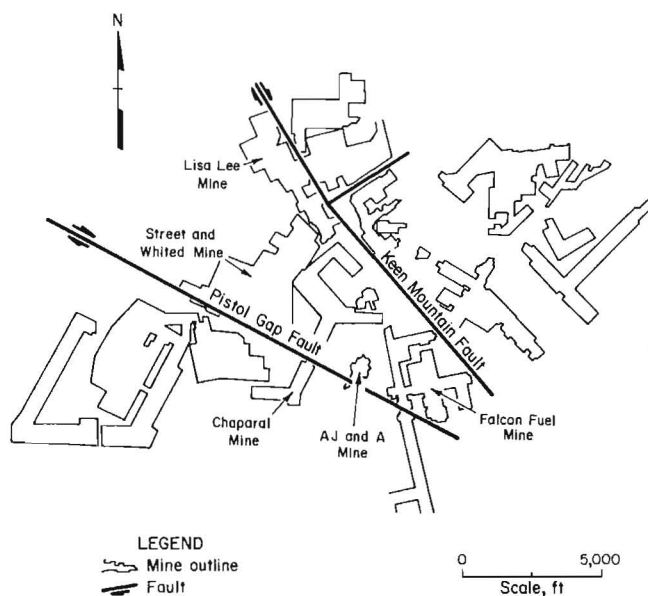
Figure 4 shows the study area with the two faults (Keen Mountain and Pistol Gap) that are affecting mining. The Keen Mountain Fault was originally mapped from SLAR imagery and can be observed in underground exposures and abandoned strip mine highwalls. The Pistol Gap Fault has not been mapped on the surface but is described in this report by underground exposure. The following are examples of the areas where these faults have affected mining.

The Falcon Fuel Mine, a contract mine to United Co., has been severely affected by the Keen Mountain and Pistol Gap Faults (fig. 4). This mine works the Jawbone Coalbed.

Figure 4.—Mines in study area affected by Keen Mountain and Pistol Gap Faults.

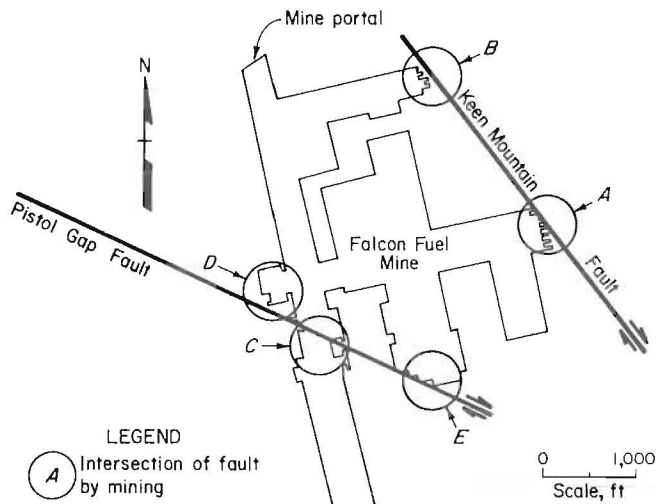
The Falcon Fuel Mine is truncated to the northeast by the Keen Mountain Fault. At location A, a seven-entry section was terminated by the truncation of the coalbed against the fault (fig. 5). Poor roof conditions and lack of coal are reported by the operator to be the causes of termination. The other development that intersected the fault is at location B (fig. 5). This five-entry section stopped against the fault trace. Exact conditions of disruption are unknown because all of the eastern developments are sealed to entry and are inaccessible for observation.

Figure 5.—Falcon Fuel Mine with developments affected by Keen Mountain and Pistol Gap Faults (circled).

At approximately 2,800 ft inby the portal, the mine first encountered the Pistol Gap Fault (figure 5, location C). The operators withdrew because of adverse roof conditions and began driving a four-entry development to the southwest (figure 5, location D). After approximately 400 ft, the development was halted as the mine again intersected the Pistol Gap Fault zone. The operators did not know at the time that the two discontinuities were the same fault zone. The southwestern development was discontinued and developments were begun to the east.

Mapping at location C indicates that compressive forces oriented northeast-southwest have caused downbuckling of the coalbed and a thrust fault-type failure in the coal and roof strata (fig. 5). Figure 6 (cross section A-A') shows that the fault runs along bedding (roof and coal interface) from A' to A until it reaches the failure zone where it turns up into the roof. Figures 7 and 8 show the coalbed thrust upward, causing a 4-ft-high roof fall (all double figures show geologic structures outlined and labeled because of the difficulty in discerning these structures). In addition, the coalbed is squeezed out to only a few inches by bedding plane movement. In figure 6 (cross section A-A'), the slippage, both at the roof-coal interface and at the floor-coal interface, has completely truncated the coalbed. Highly polished slickensides on roof shales indicate slippage along the roof-coal interface (fig. 9). Slippage occurred along bedding within the roof shale as well as within the coalbed.

The Falcon Fuel Mine intersects the Pistol Gap Fault in several other locations (fig. 5). At location E, an 11-entry section intersected the fault, which trends N. 36° W. Roof conditions were too poor to continue and the section was stopped.

When these faults are intersected, the operator usually has no idea how far the fault zone might extend. Generally, the fault is probed laterally with a continuous miner for a break to see if the fault can be easily crossed. If not, the section may be stopped and development can continue elsewhere if an acceptable place exists. At location C, it was necessary to drive through the fault zone to reach other reserves (fig. 5). This procedure was both time consuming and costly.

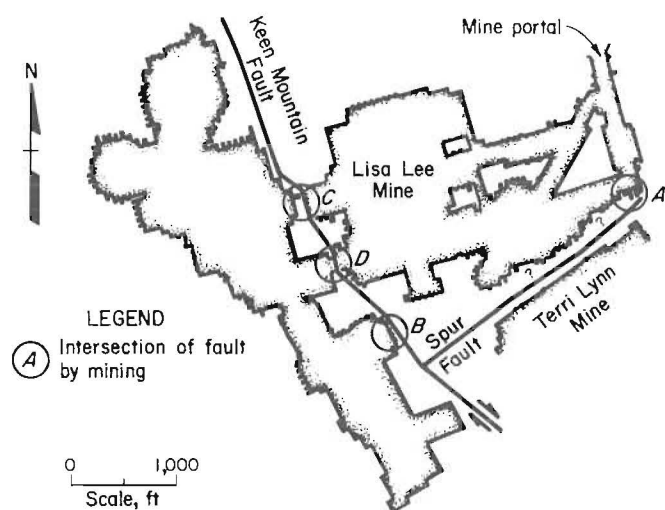
Figure 19.—Lisa Lee Mine outline and areas (circled) affected by Keen Mountain Fault.

Although the section is now flooded and inaccessible, it is suspected that the coal on the southeastern side of the fault was thrust up against and over the northwestern block, causing the overthickening. This type of overthrusting is found on other low-angle bedding plane faults in the area. Figure 19 shows that this inferred fault follows a corridor between the Lisa Lee Mine and the Terri Lynn Mine, which is located directly to the southeast and continues to adversely affect the Lisa Lee Mine along its southern border.

The Keen Mountain Fault is intersected by the Lisa Lee Mine in four places. The northeastern driving section at location B was completely stopped when it intersected the fault (fig. 19). The coalbed "ran out," and no attempt was made to drive through the zone and relocate the coal. At location C, a six-entry development was narrowed to one entry in crossing the fault. This single entry causes a severe restriction to ventilation. In addition, poor roof conditions occur at this fault intersection. The Keen Mountain Fault continues northwest through location C but is not again exposed because the Jawbone Coalbed splits are too thin to mine.

At location D (fig. 19), the Keen Mountain Fault intersects mains, which provide access to the western side of the mine. Here, an eight-entry development was necked down to three entries to cross the fault zone. The effects of the fault were mapped in detail at this crossing. Figure 20 shows part of the fault zone in cross section at location D. The zone is approximately 200 ft wide and consists of a bedding plane thrust fault and numerous roof fractures, which do not offset the coalbed, and a large coalbed swag. The main coalbed offset is 48 to 51 in, and the bed is downbuckled to the northeast. The main fault runs along bedding on the northeastern side of the offset for an

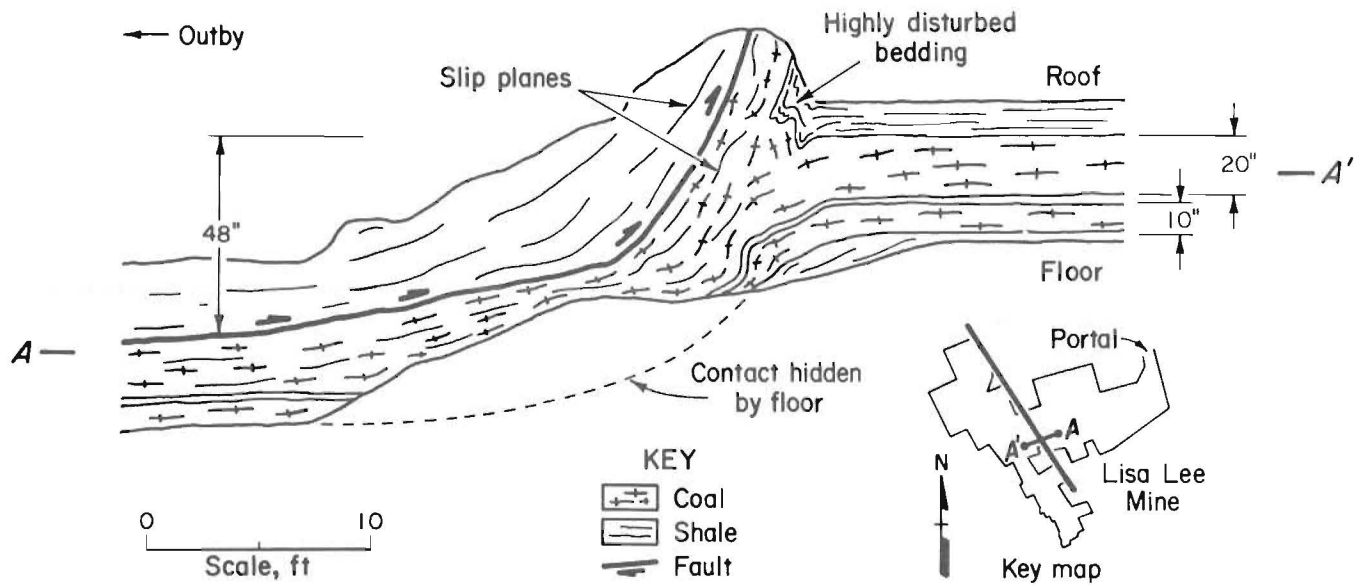
undetermined distance until it abruptly enters the roof (60°), causing a 3-ft-high fall of roof. Figure 21 shows the bedding plane fault and the associated roof disturbance. Numerous horizontal slickensides and polished surfaces indicate extensive slippage between the coal and immediate roof shales. Compression in a northeastern-southwestern direction has caused the coalbed to be dragged up into the roof and locally thickened (over 72 in). Slippage within the coalbed is apparent, and bedding is highly disturbed. The adjacent roof shales are also highly distorted. Failure occurred along the roof-coal interface and also along the bedding planes within the coalbed (fig. 21).

Figure 20.—Cross section of mining exposure of Keen Mountain Fault at Lisa Lee Mine.

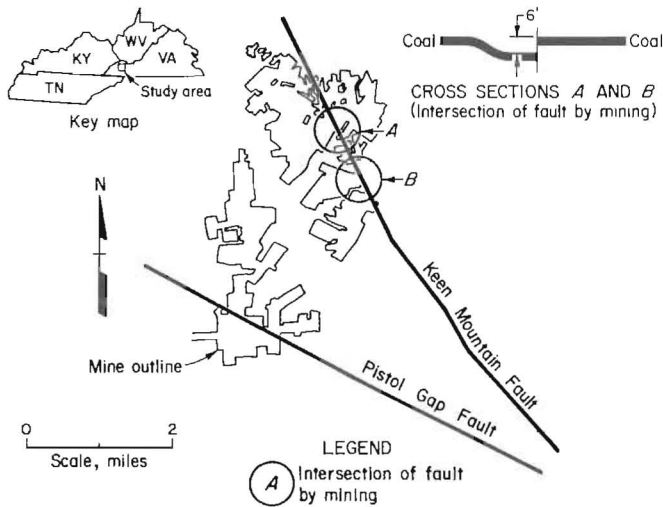
Figure 22.—Extensively mined Kennedy Coalbed affected by Pistol Gap and Keen Mountain Faults.

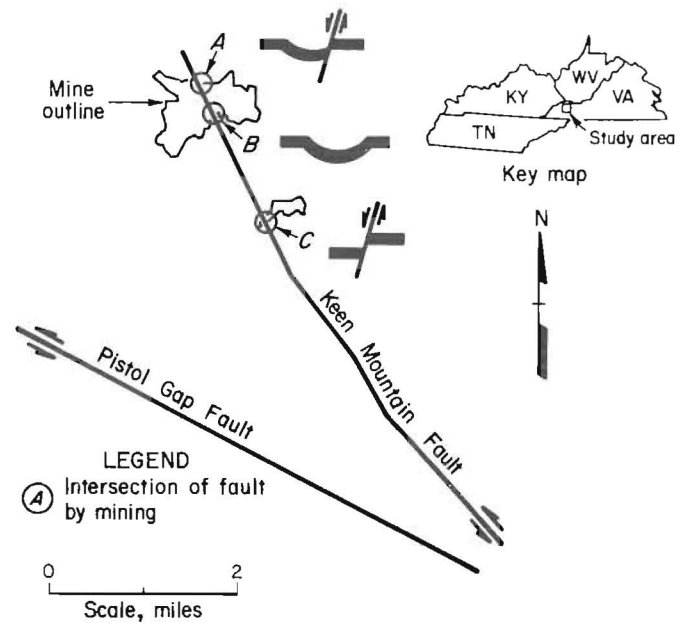
The Splashdam Coalbed is stratigraphically the highest coalbed being mined in the study area. In several instances, the Keen Mountain Fault has affected mining in this coalbed (fig. 23). In addition, the type of displacement varies between tensional, compressional, and shear movement. At location A, the coalbed is displaced 3 ft with a swag on the southwestern side. The offset is a normal tensional break with the southwestern side downdropped. At location B, the fault does not offset the coalbed but occurs as a swag, approximately 200 ft wide. The coalbed has not failed here but has only been downbuckled. This indicates not only the intensity but that the type of movement on the fault has changed in slightly over 1,000 ft. At location C, the fault was exposed in a strip mine highwall. This offset was a normal tensional break with about 3 ft of offset (figure 23, western side down-dropped). The fault was actually a zone about 200 ft wide with zones of vertical fractures spaced every 20 ft. There is another highwall exposure of the fault shown in figure 24. Here, the offset is a normal tensional offset of about 18 in.

Figure 23.—Exposures of Pistol Gap and Keen Mountain Faults in mined-out Splashdam Coalbed.

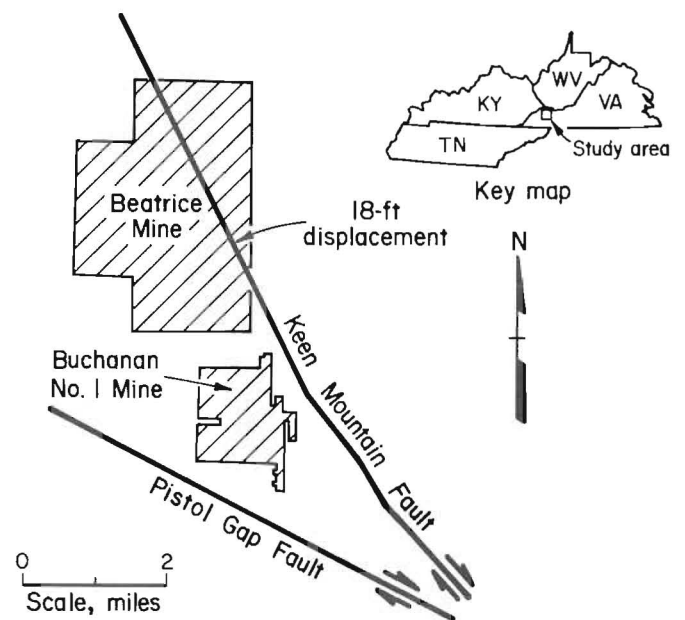
The Keen Mountain Fault appears to have a much larger displacement at greater depth from the surface (>1,500 ft deep). The Pocahontas #3 Coalbed at Island Creek Coal Co.'s Beatrice Mine (now closed) had been displaced up to 18 ft by the fault (5) (fig. 25). Preliminary seismic information from above Consolidation Coal Co.'s Buchanan No. 1 Mine, also in the Pocahontas #3 Coalbed, indicates up to 20 ft of displacement (9). At all exposures, strike-slip movement is indicated by slickensides and fault gouge.

Figure 25.—Shaft mines in Pocahontas #3 Coalbed (deepest mined) affected by Keen Mountain Fault.
